## TEST REPORT

No. : SHIN1402006081MR

Sample Name : MVT800 GPS Vehicle Tracker  
SGS Ref. No. : SHIN1402005961PS  
Product Specification : IP65  
Date of Receipt : Feb 24, 2014  
Testing Start Date : Feb 24, 2014  
Testing End Date : Feb 27, 2014  
Test result(s) : For further details, please refer to the following page(s)

No.	Test Item	Test Method	Result	Conclusion
1.	IP6X	IEC 60529:2001 and Client's Requirement	See Test Result	Pass
2.	IPX5	IEC 60529:2001 and Client's Requirement	See Test Result	Pass

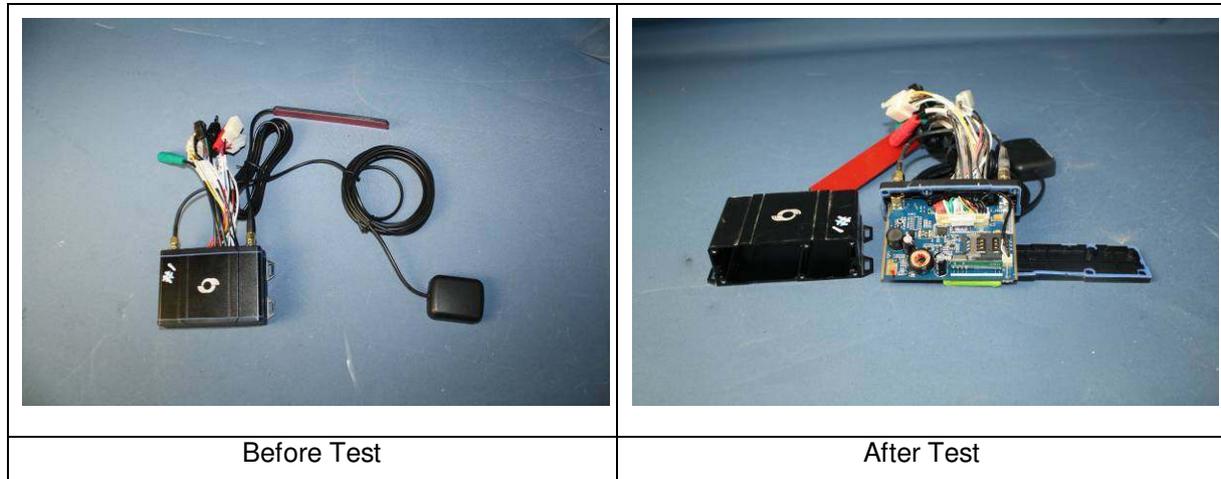
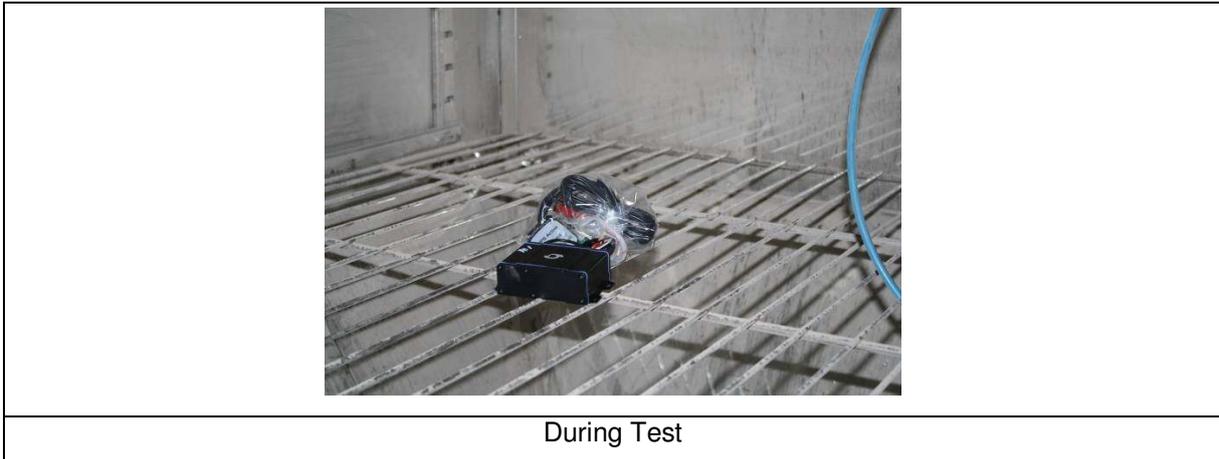
Test Photo:

Test Item1: IP6X

Test Dust: Talcum powder

Dust Concentration: 2kg/m3 chamber volume and be kept in suspension during the test

Test Duration: 8hours

Sample	Test Result	Conclusion
#1	No dust ingress was found in the sample after test.	Pass

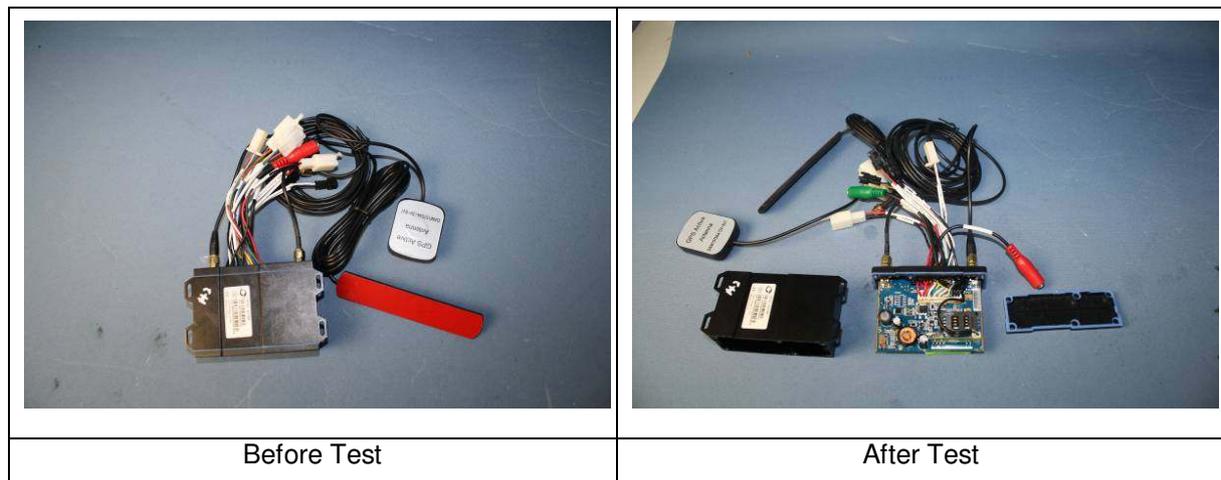
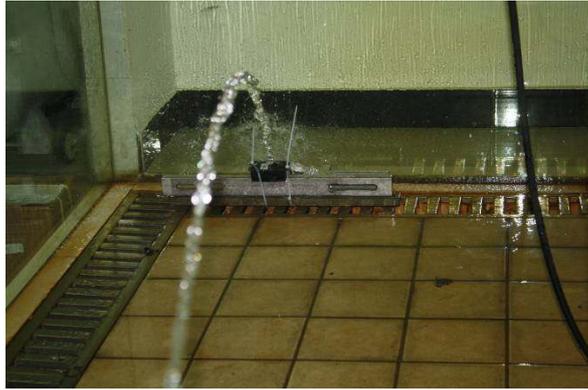
Test Photo:

Test Item2: IPX5

Nozzle diameter:  $\Phi$ 6.3mm

Flow rate: 12.5LPM

Distance: 2.5m~3.0m

Test duration: 3min

Sample	Test Result	Conclusion
#2	No water ingress was found in the sample after test.	Pass

During Testing
